# **Implementing Traffic Safety Evaluations to Enhance Roadway Safety**

Upper Great Plains Transportation Institute  
North Dakota State University  
Fargo, ND 58108

May 2010

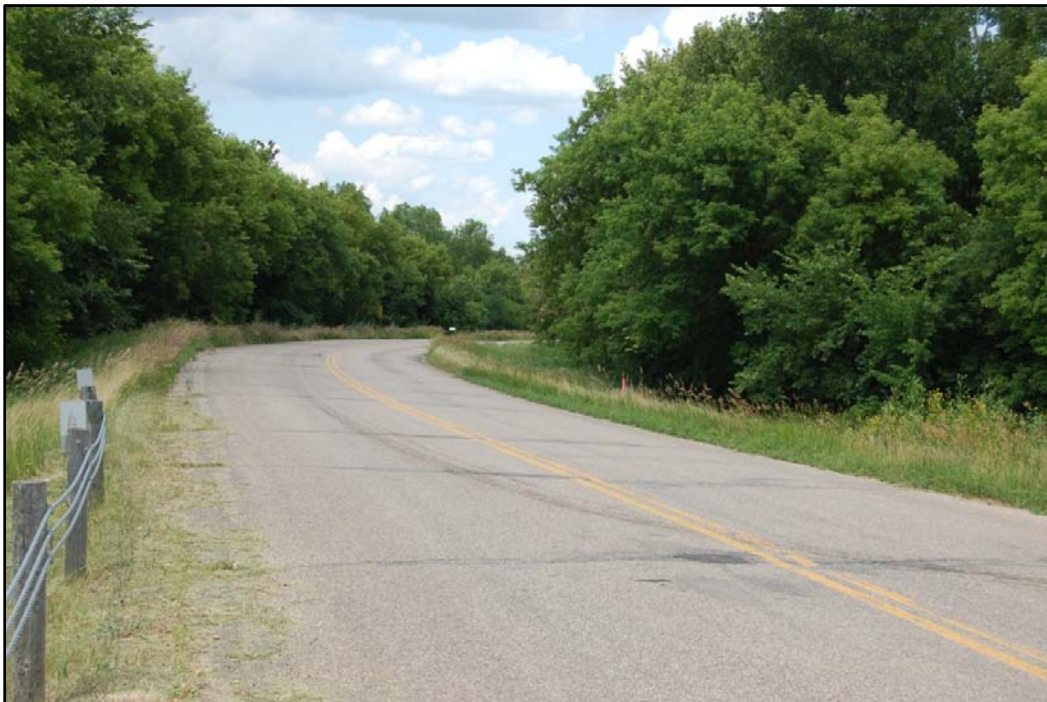
This roadway is also classified as a Scenic Byway, and is part of the Sheyenne River Valley Scenic Byway. This section of roadway was identified by Barnes County personnel due to perceived safety issues at several locations. The scenic byway portion of Highway 21 has several horizontal and vertical curves, most of which are located south of Valley City. In addition to the curvature, there are several locations which have limited clear-zone distances due to vegetation (Figure 3.3).

**Figure 3.3** Roadway Curvature and Limited Clear Zone

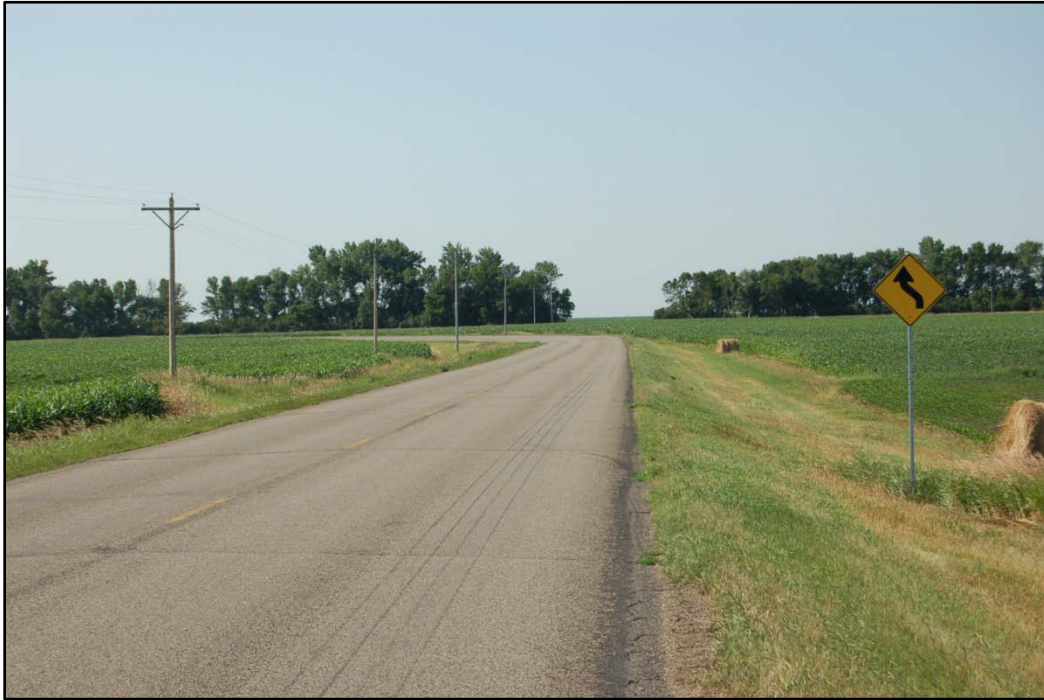
The first site evaluated was a large horizontal curve approximately three miles north of Valley City (Figures 5.1-5.2). It was noted that several run-off-the-road crashes have occurred at this location, with one resulting in a fatality. In addition to the roadway curvature, there are other characteristics which contributed to the safety issues at this location. An intersection with a gravel road, which isn't aligned perpendicular to the highway, is located at the midway point between the two horizontal curves. This alignment may potentially cause some sight-distance issues and driver confusion. In addition, several trees are located in the vicinity of the southern edge of the curve (Figure 5.2).

**Figure 5.1** Horizontal curve north of Valley City

- Install edgeline rumble strips
- Install centerline rumble stripes
- Widen the shoulders on the curves
- Install dynamic speed advisory signs to alert drivers to their speed
- Re-align the gravel road (30<sup>th</sup> St. SE) so it is perpendicular to Highway 21

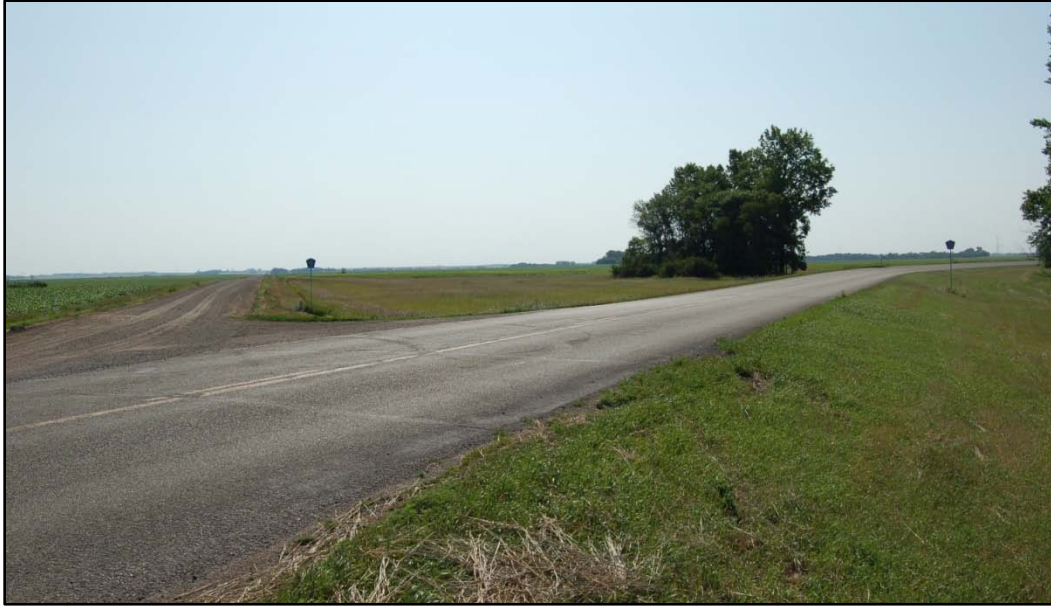
**Figure 5.2** Intersection in the middle of the horizontal curve  
Note: photo was taken facing to the southeast

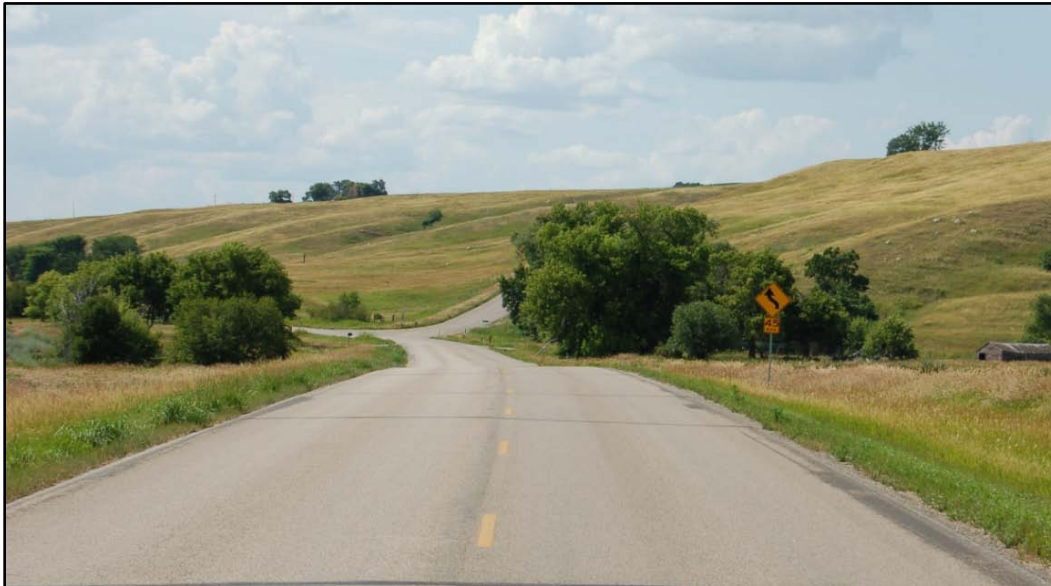
The second site which was evaluated was located to the northwest of Valley City and consisted of an intersection on a horizontal and vertical curve (Figure 5.3). There were several characteristics about this intersection which cause safety issues such as, intersection alignment, approach grade and roadway material, and sight distance.

**Figure 5.3** Approaching the Bloomberg Hill intersection from the southeast

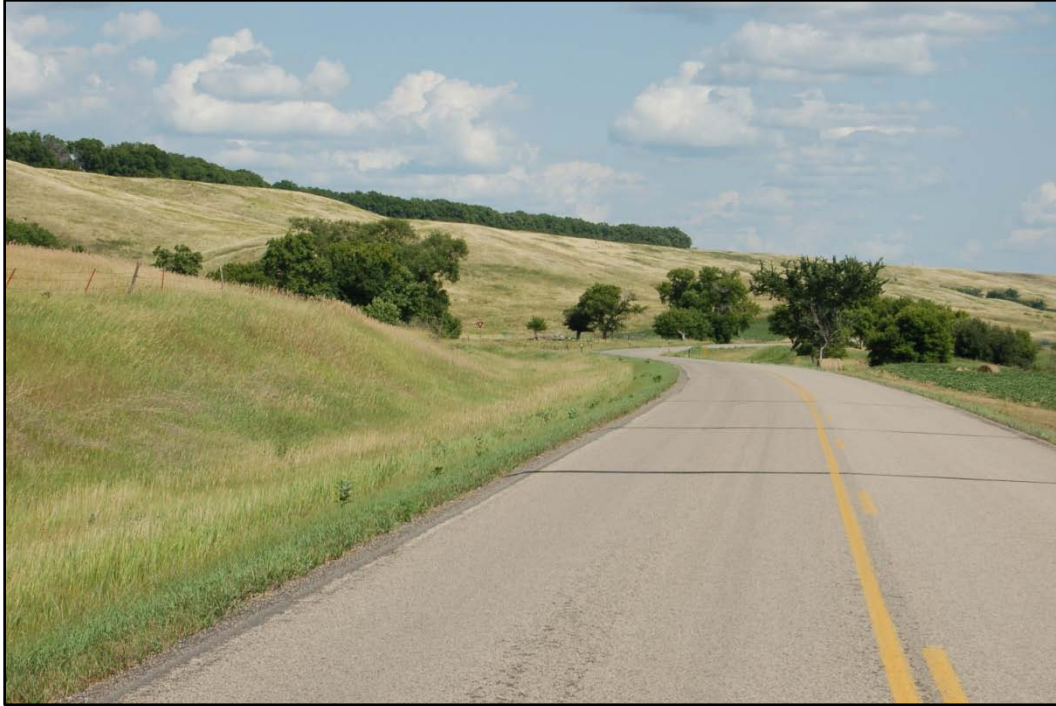
The paved highway intersects with a gravel road, which approaches the intersection at a significant downgrade. Due to the alignment of the intersection and orientation of the gravel road, it is extremely difficult to see the intersection and gravel road when approaching from the north on the paved roadway (Figure 5.4).

**Figure 5.4** Approaching the Bloomberg Hill intersection from the northwest.

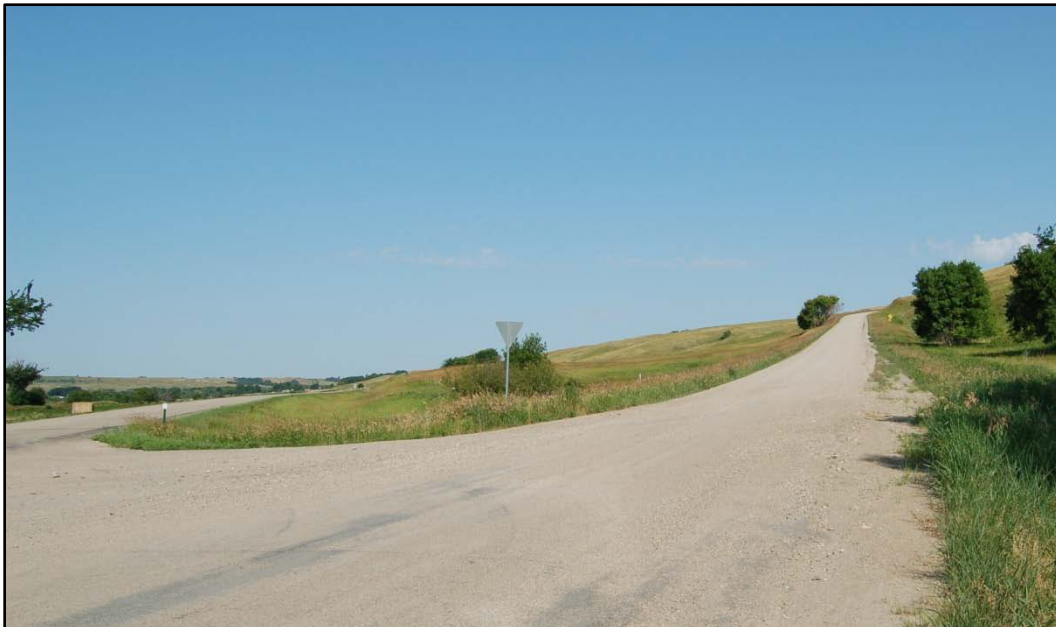
Several small trees and shrubs are located in the northwest quadrant of the intersection and block the view to the northwest for vehicles approaching the intersection on the gravel road. This is compounded by the fact that the intersection alignment already makes the view of oncoming traffic difficult (Figure 5.5).

**Figure 5.5** Obstruction and alignment issues at the Bloomberg Hill intersection

- Install edgeline rumble strips
- Install centerline rumble stripes
- Re-align the intersection so the gravel road is perpendicular to the highway
- Widen the shoulders on the curve

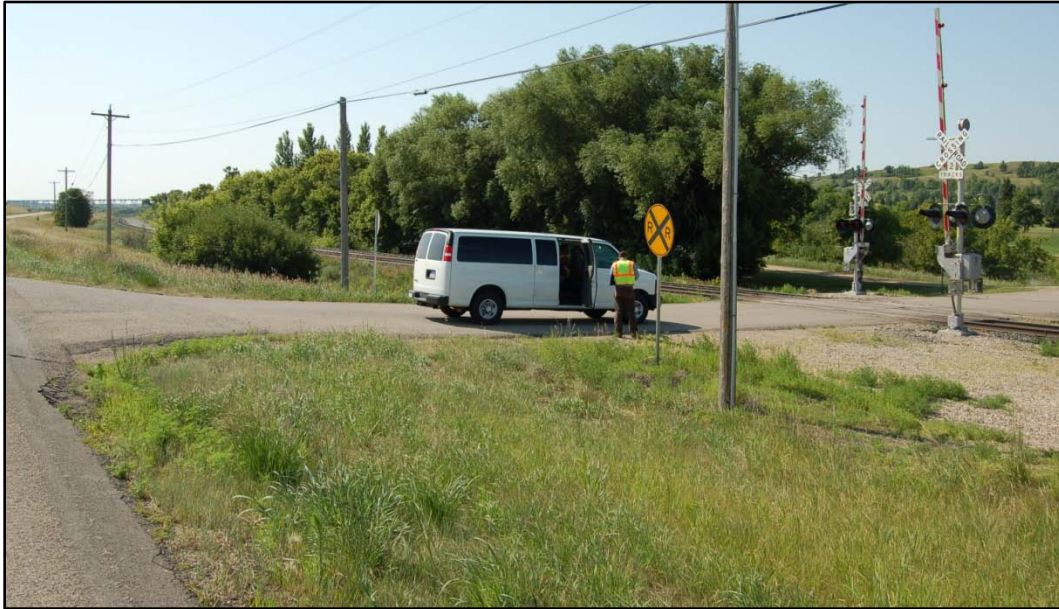
A railroad runs parallel to the highway northwest of Valley City (in the vicinity of Bloomberg Hill), and has access roads crossing at certain locations. One of these crossings was examined during the site visit. It was noted that when a train was present, the storage of the approach to the crossing may be insufficient in preventing spillback onto the highway (Figure 5.6).

**Figure 5.6** Railroad crossing northwest of Valley City, N.D.

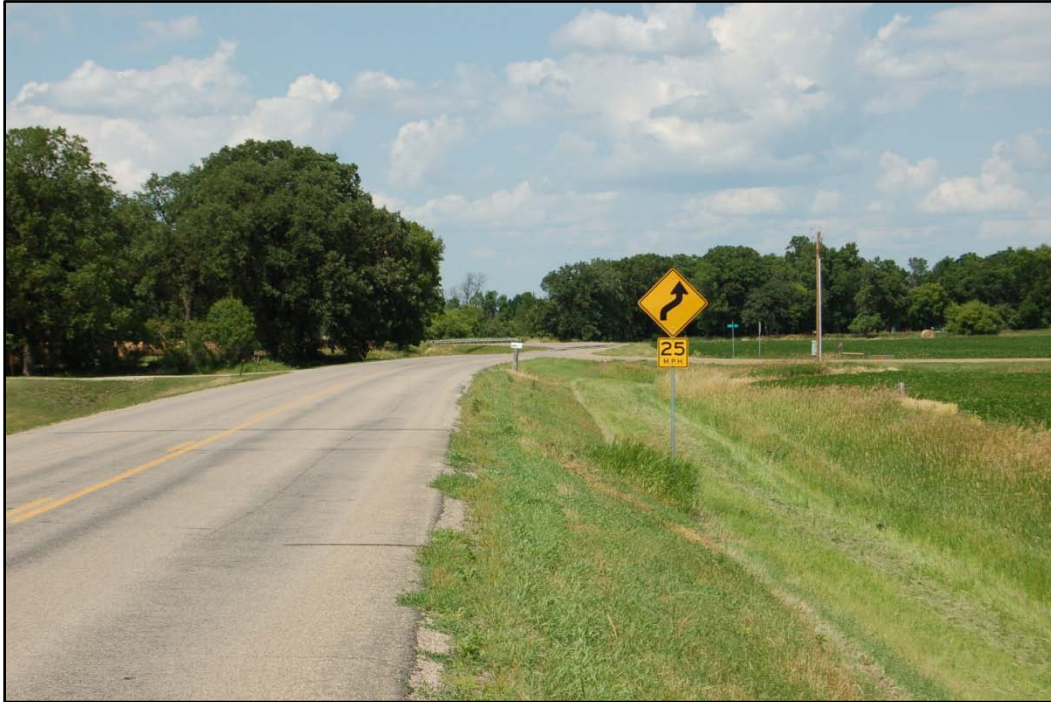
Approximately three miles south of Valley City, the evaluation team examined a bridge located on a horizontal curve along Highway 21 (Figure 5.7). Comments from this location regarded excessive speed and the narrowness of the bridge. Past observations have shown that due to the narrowness of the bridge, drivers tend to track along the center of the road when crossing. Proactive measures have been taken to improve the safety of this location through the addition of a speed advisory plate on the curve sign and updated guardrails at the bridge.

**Figure 5.7** Bridge and horizontal curve south of Valley City, N.D.

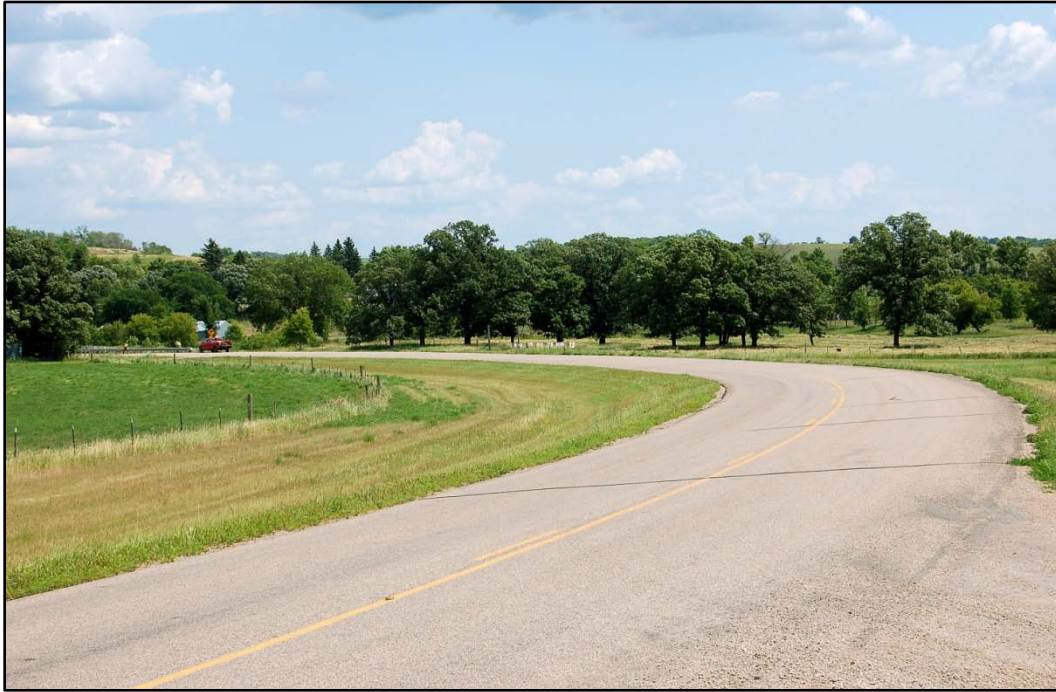
One of the most significant safety issues was observed approximately halfway between Valley City and Kathryn. This location is referred to as Skorpen Curve, and has been the site of several crashes. Skorpen Curve consists of a large reverse curve, with a bridge crossing the Sheyenne River at the midpoint. The north end of the curve includes an intersection with a gravel road (Figure 5.8).

**Figure 5.8** North end of Skorpen Curve  
Note: Photo was taken facing to the southeast

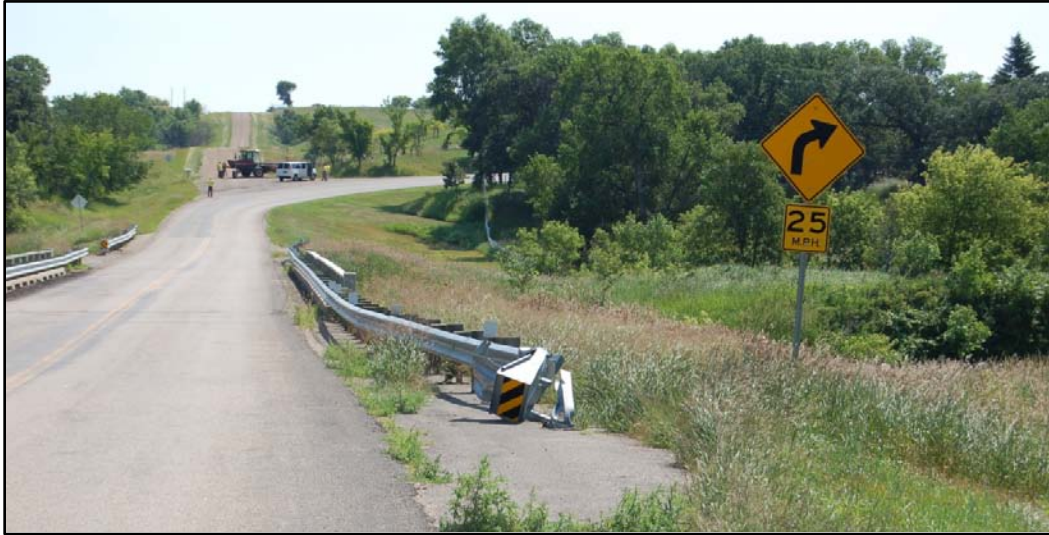
The bridge at the midpoint of the reverse curve is relatively narrow in comparison to the roadway, which results in the road having no shoulder on the bridge (Figure 5.9). It was observed during the site visit that the southbound guardrail attenuator was damaged, indicating that it had been struck by a vehicle. It should be noted that a road crew was repairing the guardrail at the time of the field visit.

**Figure 5.9** Bridge at Skorpen Curve

- Install edgeline rumble strips
- Install centerline rumble strips
- Install dynamic speed advisory signs to alert drivers to their speed
- Widen the shoulders on the curves and bridge

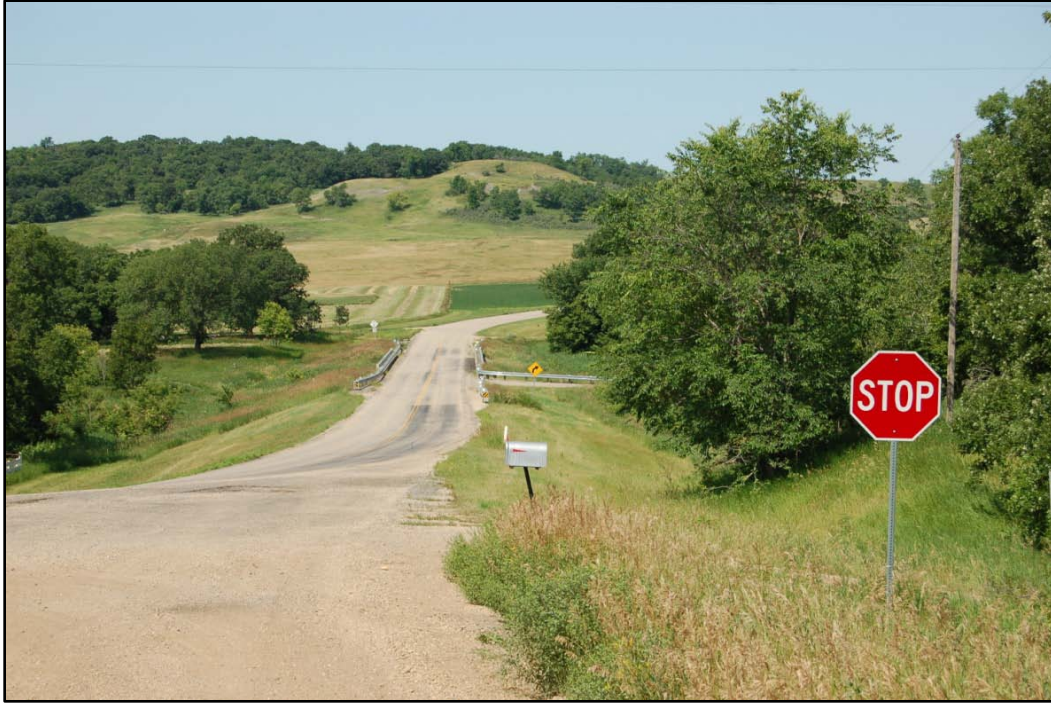
The south end of Skorpen Curve also intersects with a gravel road (Figures 5.10-5.11). This intersection had several safety issues, which were noted by the evaluation team. Due to the alignment of the intersection, vehicles travelling southbound on Highway 21 may think that the roadway continues straight, especially in low-light or inclement weather conditions (Figure 5.9). This alignment may cause drivers to inadvertently run off the road.

Vehicles approaching Highway 21 on the gravel road from the east have several factors to consider. The approach to the intersection with Highway 21 is on a downgrade and controlled by a stop sign (Figures 5.10-5.11). This may be hazardous for drivers unfamiliar with the roadway (especially if they don't see the stop sign and think the road continues straight).

**Figure 5.10** Westbound approach at the south end of Skorpen Curve

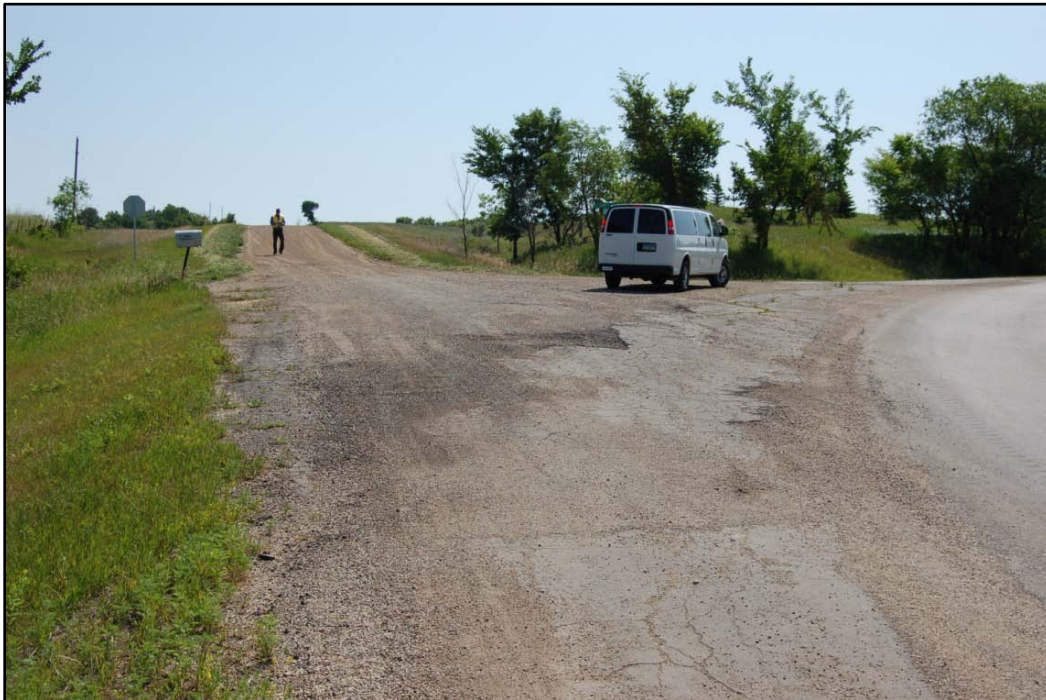
**Figure 5.11** Westbound approach at Skorpen Curve  
Note: Photo was taken facing to the east

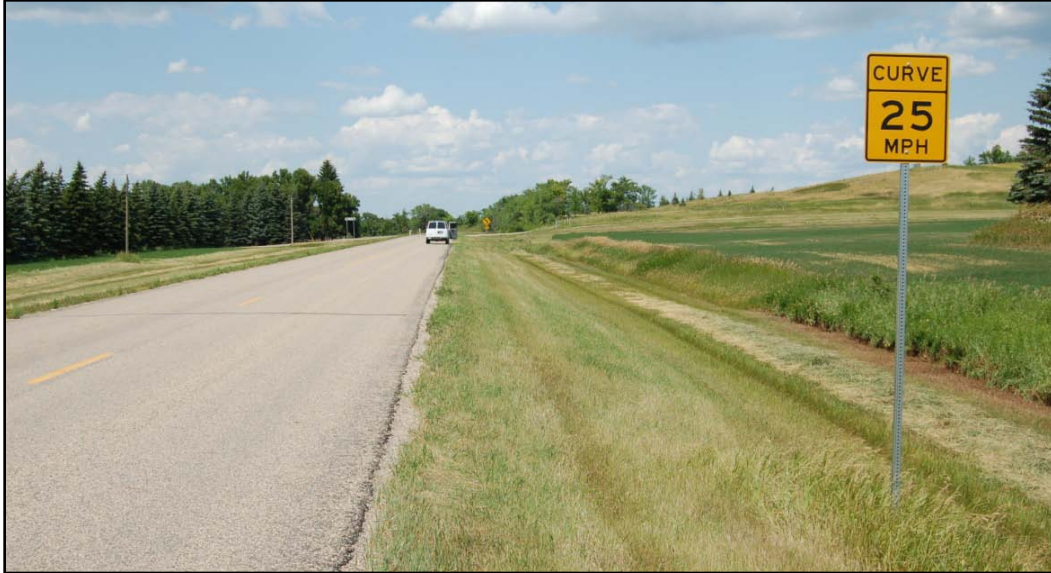
Vehicles approaching Skorpen Curve from the south have two speed advisory signs warning of the roadway curve (Figures 5.12-5.13). It was noted that the northbound direction at this location had a history of safety issues, primarily related to speeding. The advanced speed advisory sign was added in 2007 to encourage drivers to reduce their speed.

**Figure 5.12** Advanced speed advisory sign (northbound at Skorpen Curve)

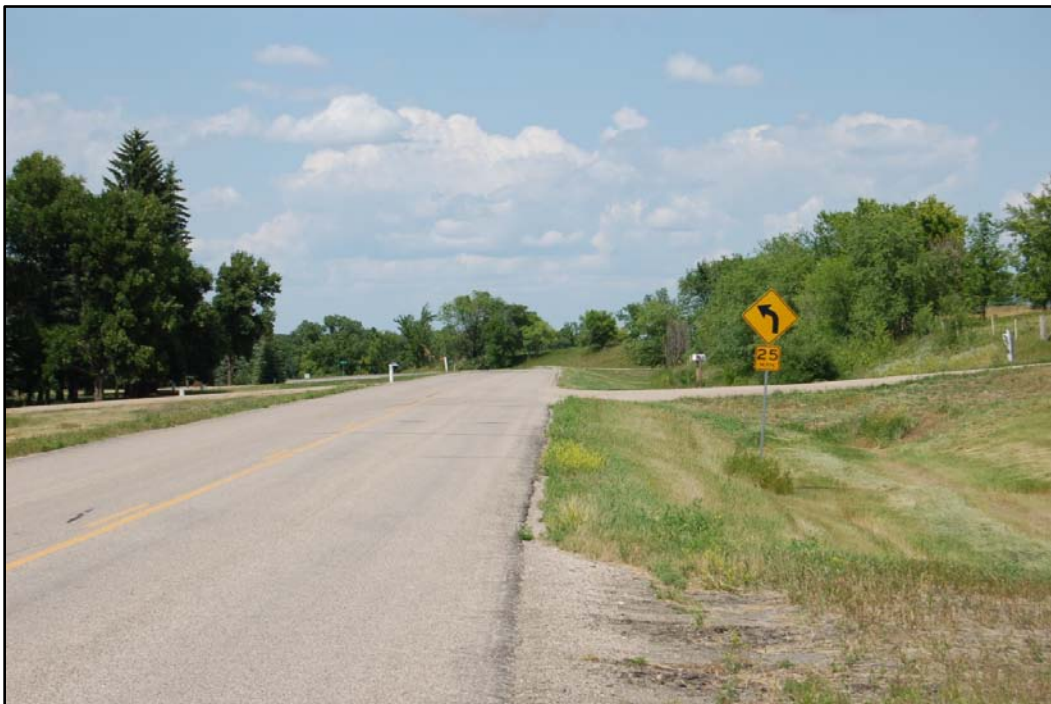
**Figure 5.13** Curve advisory sign and speed limit sign at Skorpen Curve

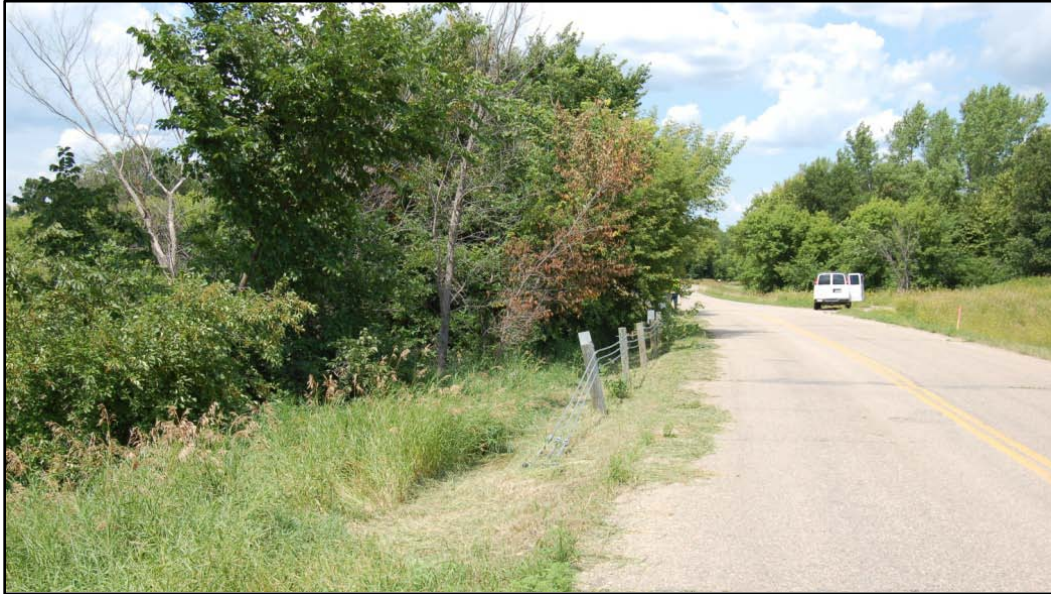
It was observed during the site visit that several horizontal curves were located on a section of road approximately five miles north of Kathryn (Figures 5.14-5.16). The safety issues observed at this location were primarily due to the close proximity of vegetation to the roadway. This results in limited sight distance at the curves, and requires drivers to reduce speed. It should be noted that the Sheyenne River is adjacent to Highway 21 at this location, and road crews have difficulty trimming vegetation close to the river. Guardrails have been placed at locations where the road is close to the river and locations where trees are adjacent to the road.

**Figure 5.14** Vegetation growth along the road shoulder  
Note: Sheyenne River is located on the left side of the photo

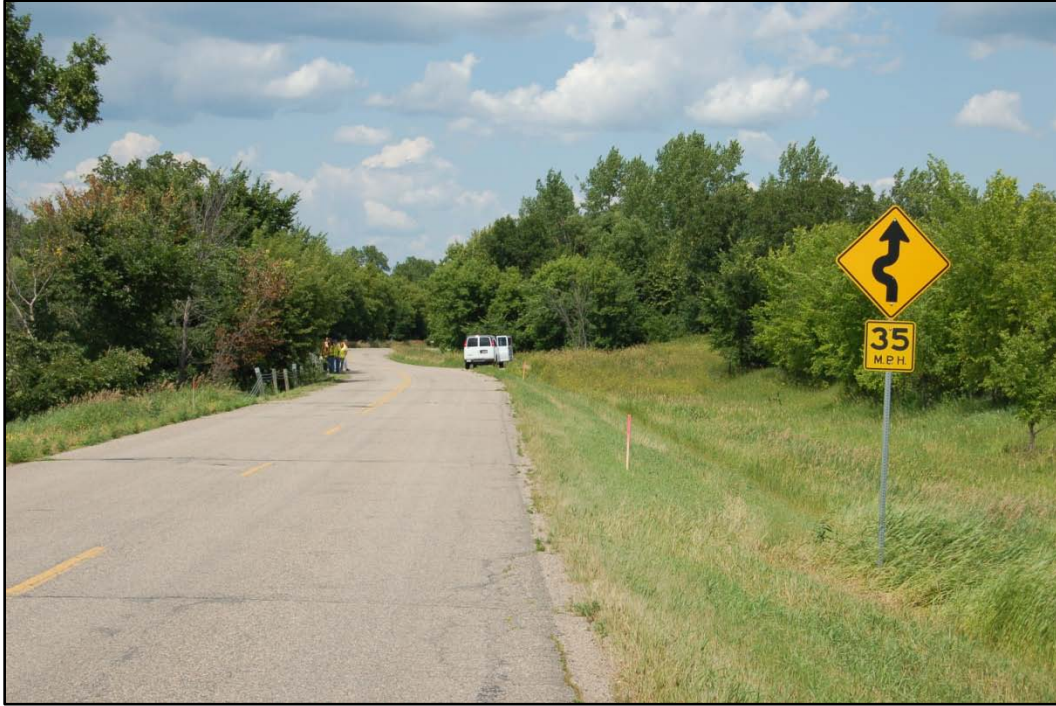
**Figure 5.15** Speed advisory sign and horizontal curves

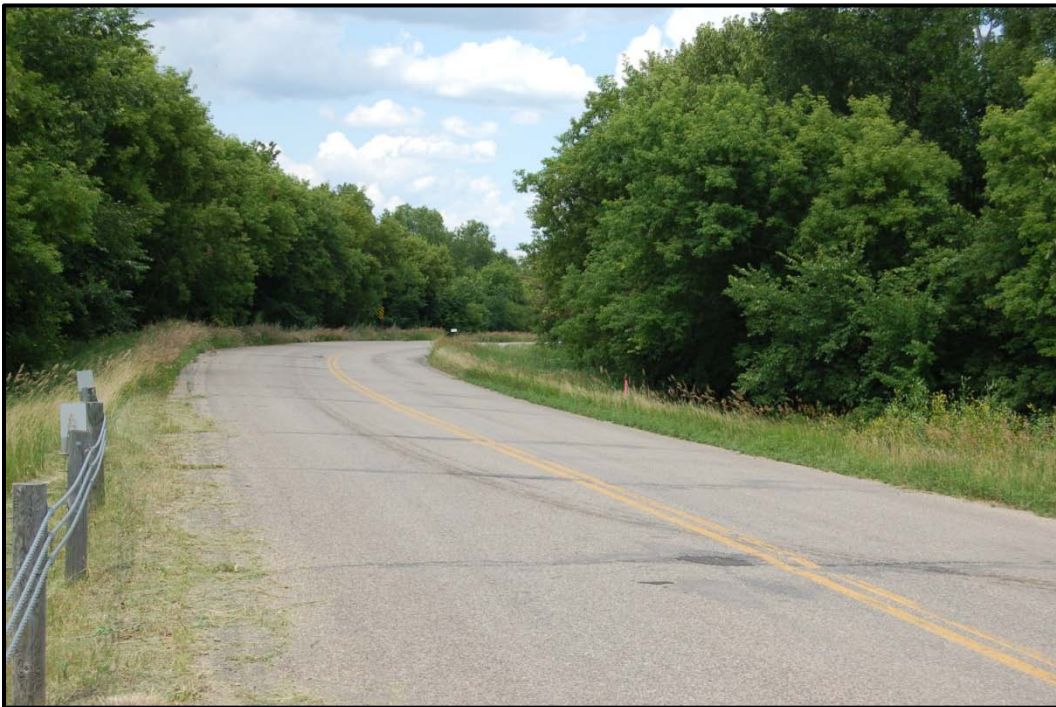
**Figure 5.16** Clear zone encroachment due to vegetation

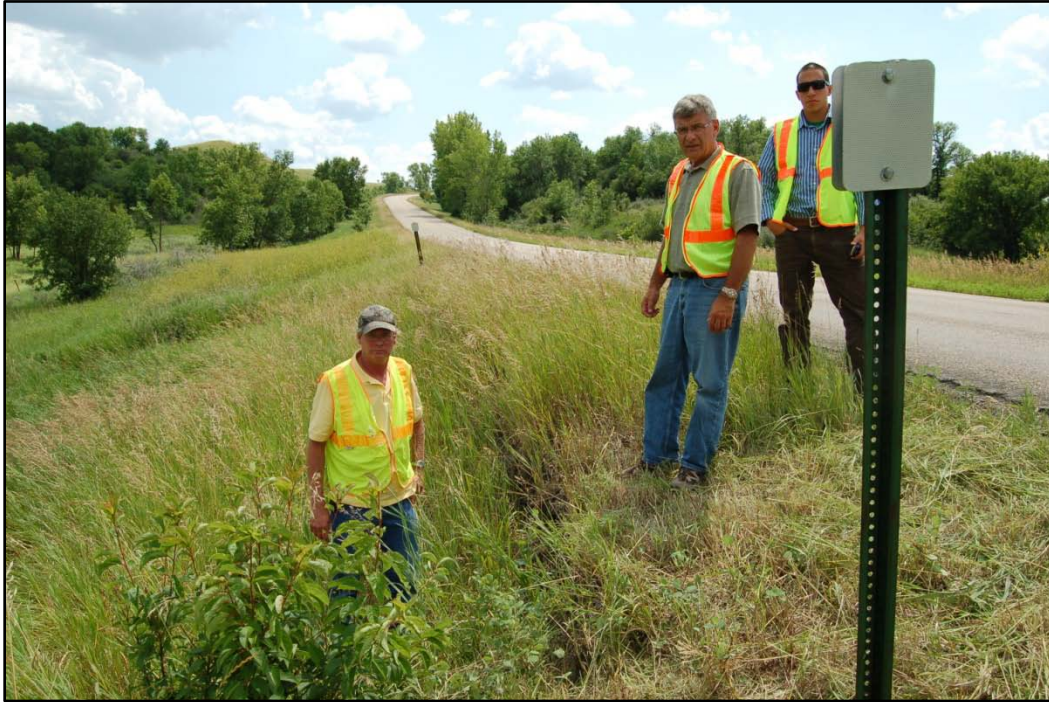
The evaluation team examined a location at which the roadway in-slope is unstable (Figures 5.17-5.18). This instability is causing the in-slope to slide (slough) approximately eight feet from the edge of the road shoulder. At the time of the site visit, the slough was approximately four feet deep (in comparison to the existing grade). In addition to the slough, the in-slope itself is considerably steep at this location. It was noted that a previous repair of the in-slope slough only lasted a few weeks before it began sliding again. There were no safety devices at this location except for two posts delineating the edges of the slough.

**Figure 5.17** Roadway in-slope slough

This location received the same ranking as Bloomberg Hill due to the safety issues caused by the in-slope instability. Although there are several temporary solutions to improve the safety at this location, it will be necessary to remediate the soil instability before the structure of the roadway facility becomes affected. The recommended improvement strategies for this location are as follows:

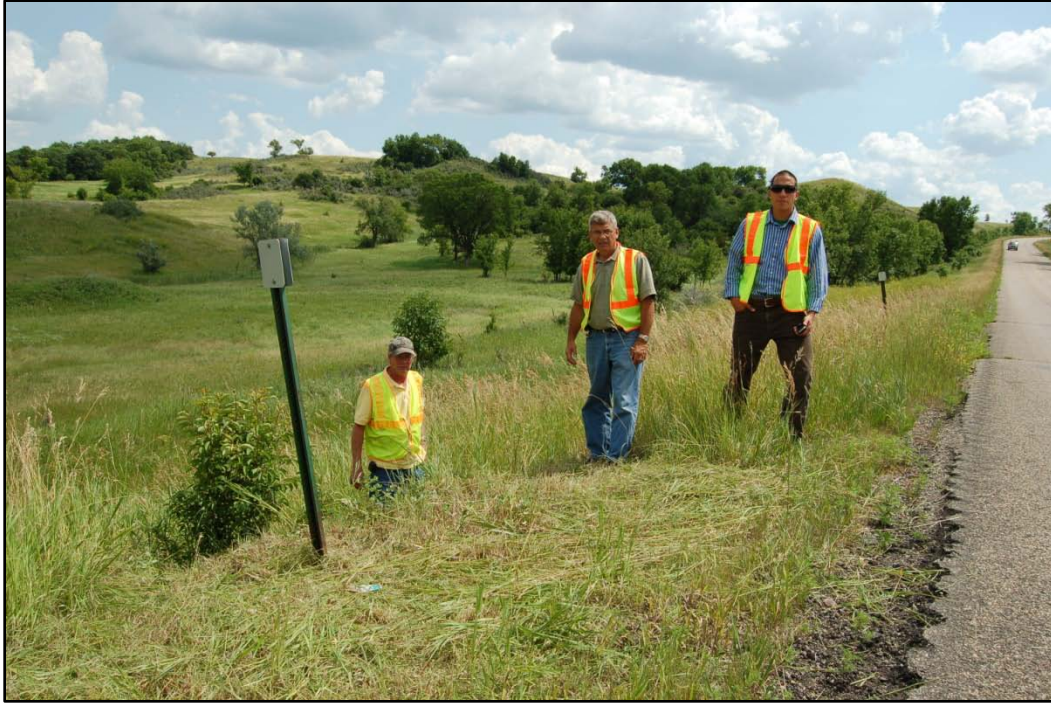
**Figure 5.18** Roadway in-slope slough

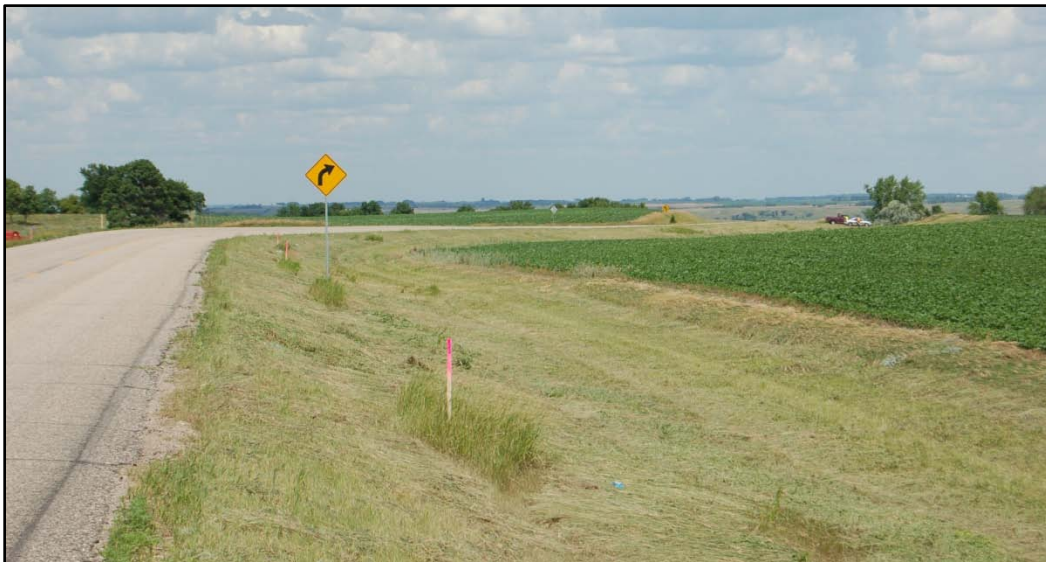
Several curves were observed on Highway 21 southwest of Kathryn (Figures 5.19-5.21). Although there were no obvious sight-distance issues caused by vegetation, some of the curves had relatively small radii due to the landscape, which required speed reductions to 35 mph.

**Figure 5.19** Large horizontal curve on Highway 21

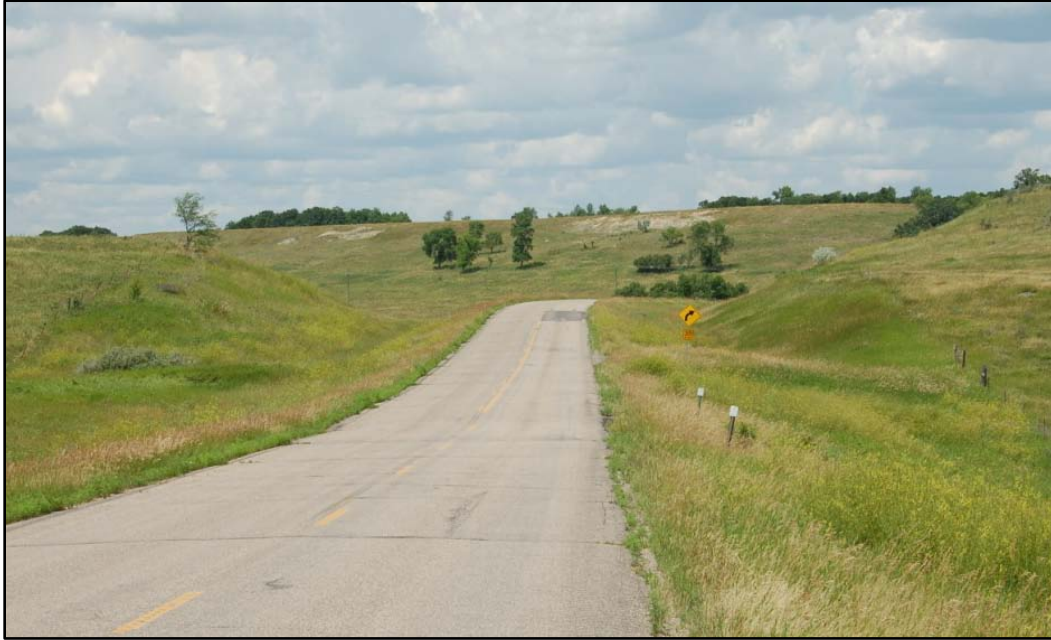
**Figure 5.20** Horizontal curve with speed reduction

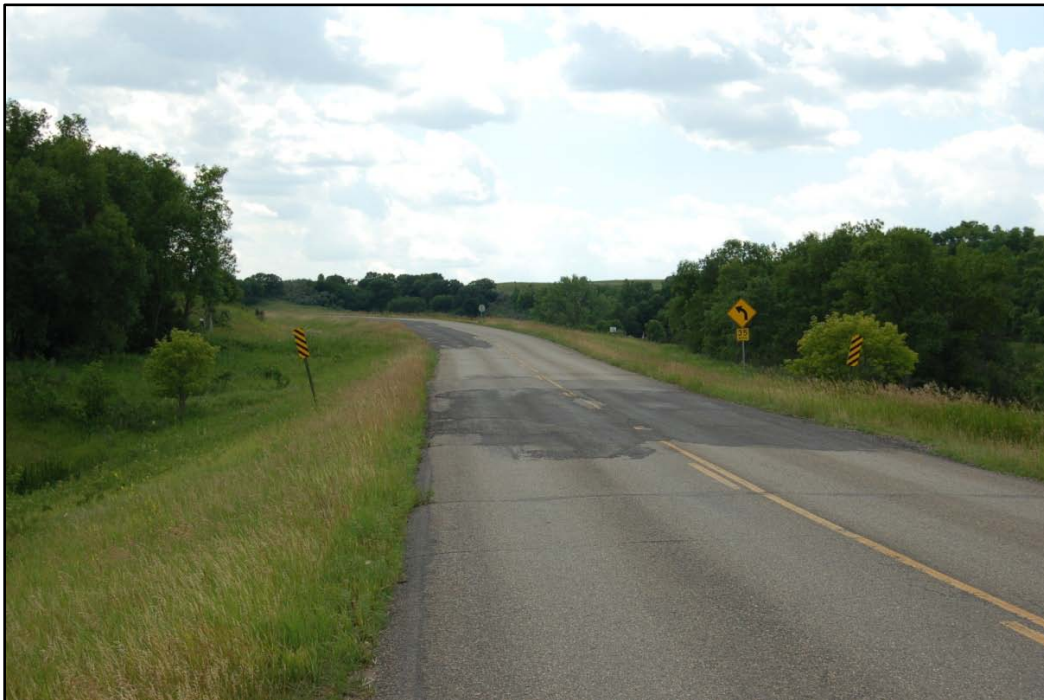
**Figure 5.21** Horizontal curve with speed reduction and culvert delineators

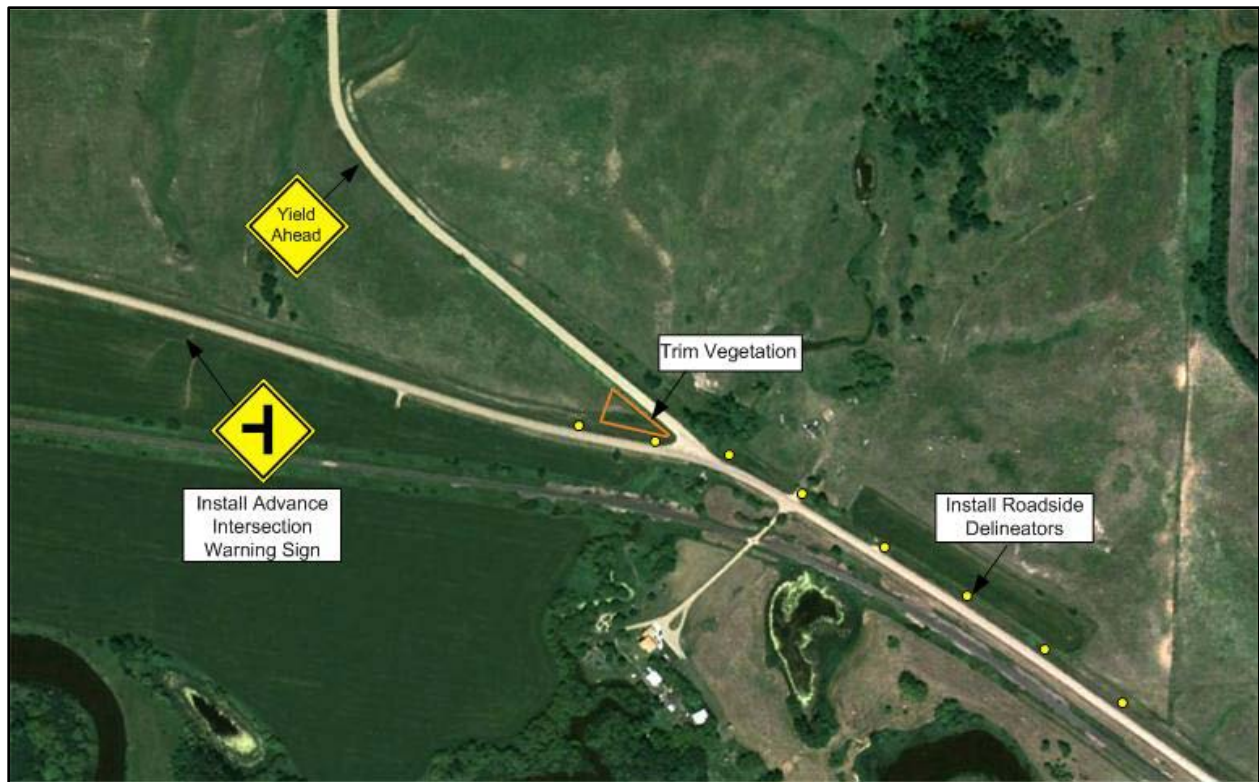
**Figure 6.1** Improvement suggestions for Bloomberg Hill

This location was perceived to have the highest safety issue as noted by the ranking done by members of the evaluation team. There are several recommended suggestions for improvement at this location (Figure 6.1). The various improvement strategies are listed as follows:

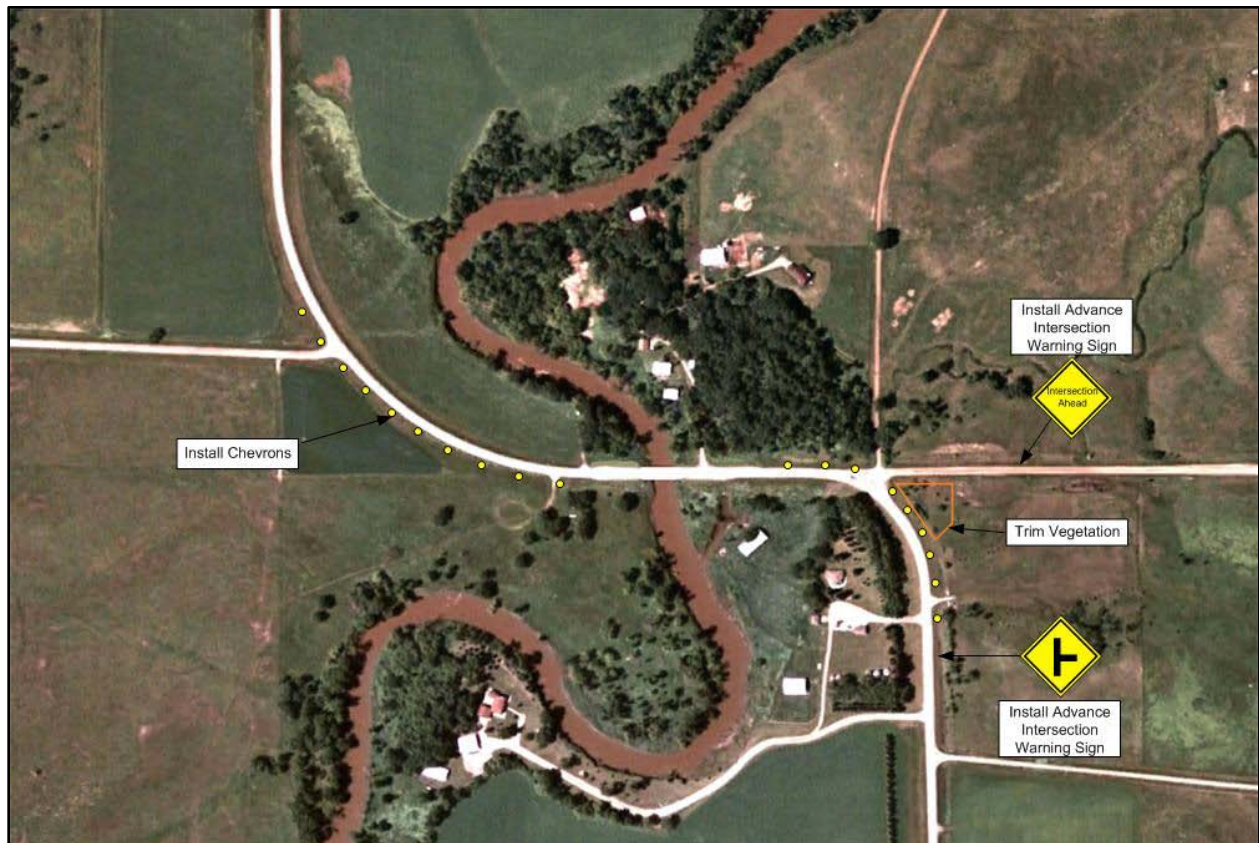
**Figure 6.2** Short-term improvements for Skorpen Curve

Although this location was not ranked as high as the previous two, the ranking was only lower by .25, which illustrates the importance of evaluating the safety of this curve. It should be noted that two of the respondents ranked this location as having the worst safety issues (see Appendix B). The general layout and safety issues at Skorpen Curve are relatively similar in nature to the issues encountered at Bloomberg Hill, with a few exceptions. As a result, the strategies for improving the safety at this location are similar (Figure 6.2). The improvement strategies for Skorpen Curve are listed at follows:

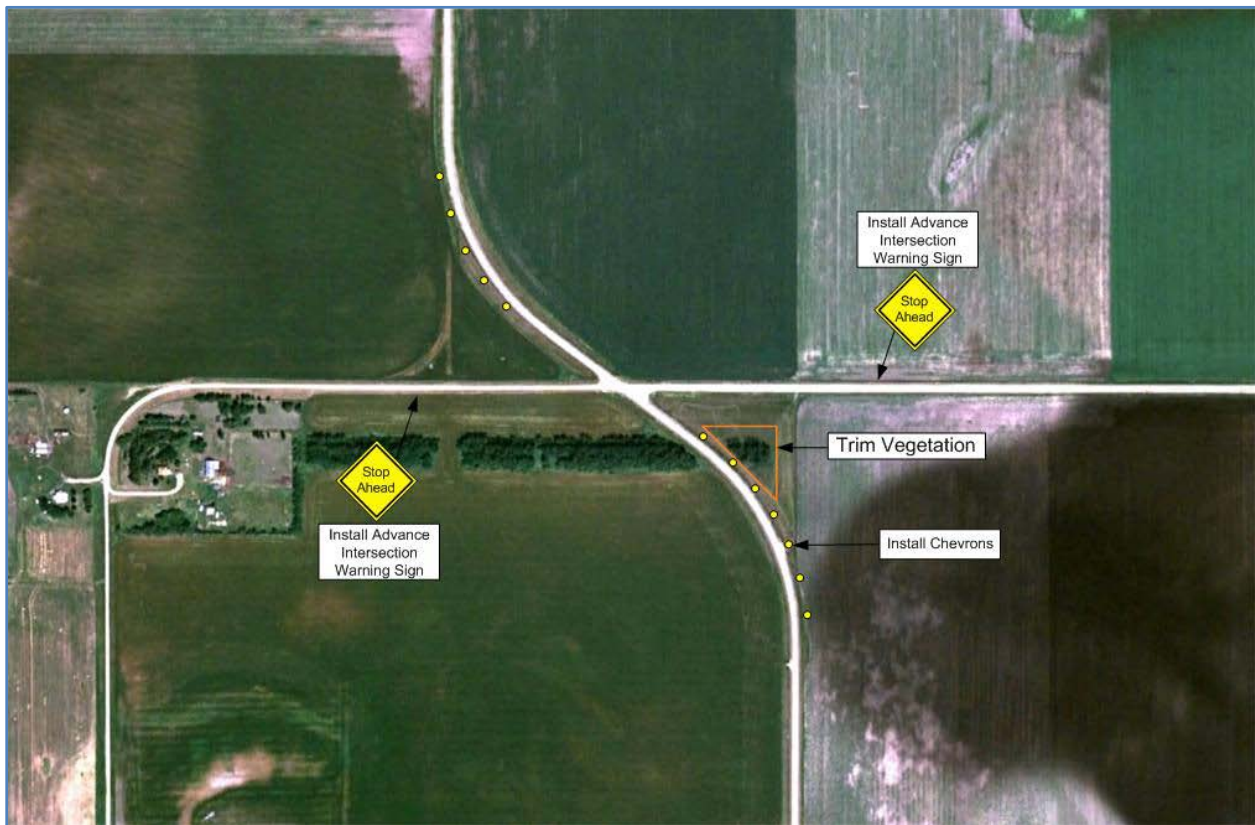
**Figure 6.3** Short-term improvement suggestions for the curve north of Valley City

This location was examined by the evaluation team due to concerns resulting from previous crashes (one of which resulted in a fatality). This location is a reverse curve having similar safety issues as the others, such as vegetation/trees blocking the view and an intersection at the center of the curve. This location had a ranking of 3.5, with the highest respondent ranking of 2 (Appendix B). The recommended safety improvements for this location are listed as follows:
