Areas of Landslides

Robinson Lake Quadrangle, North Dakota

Edward C. Murphy

2011

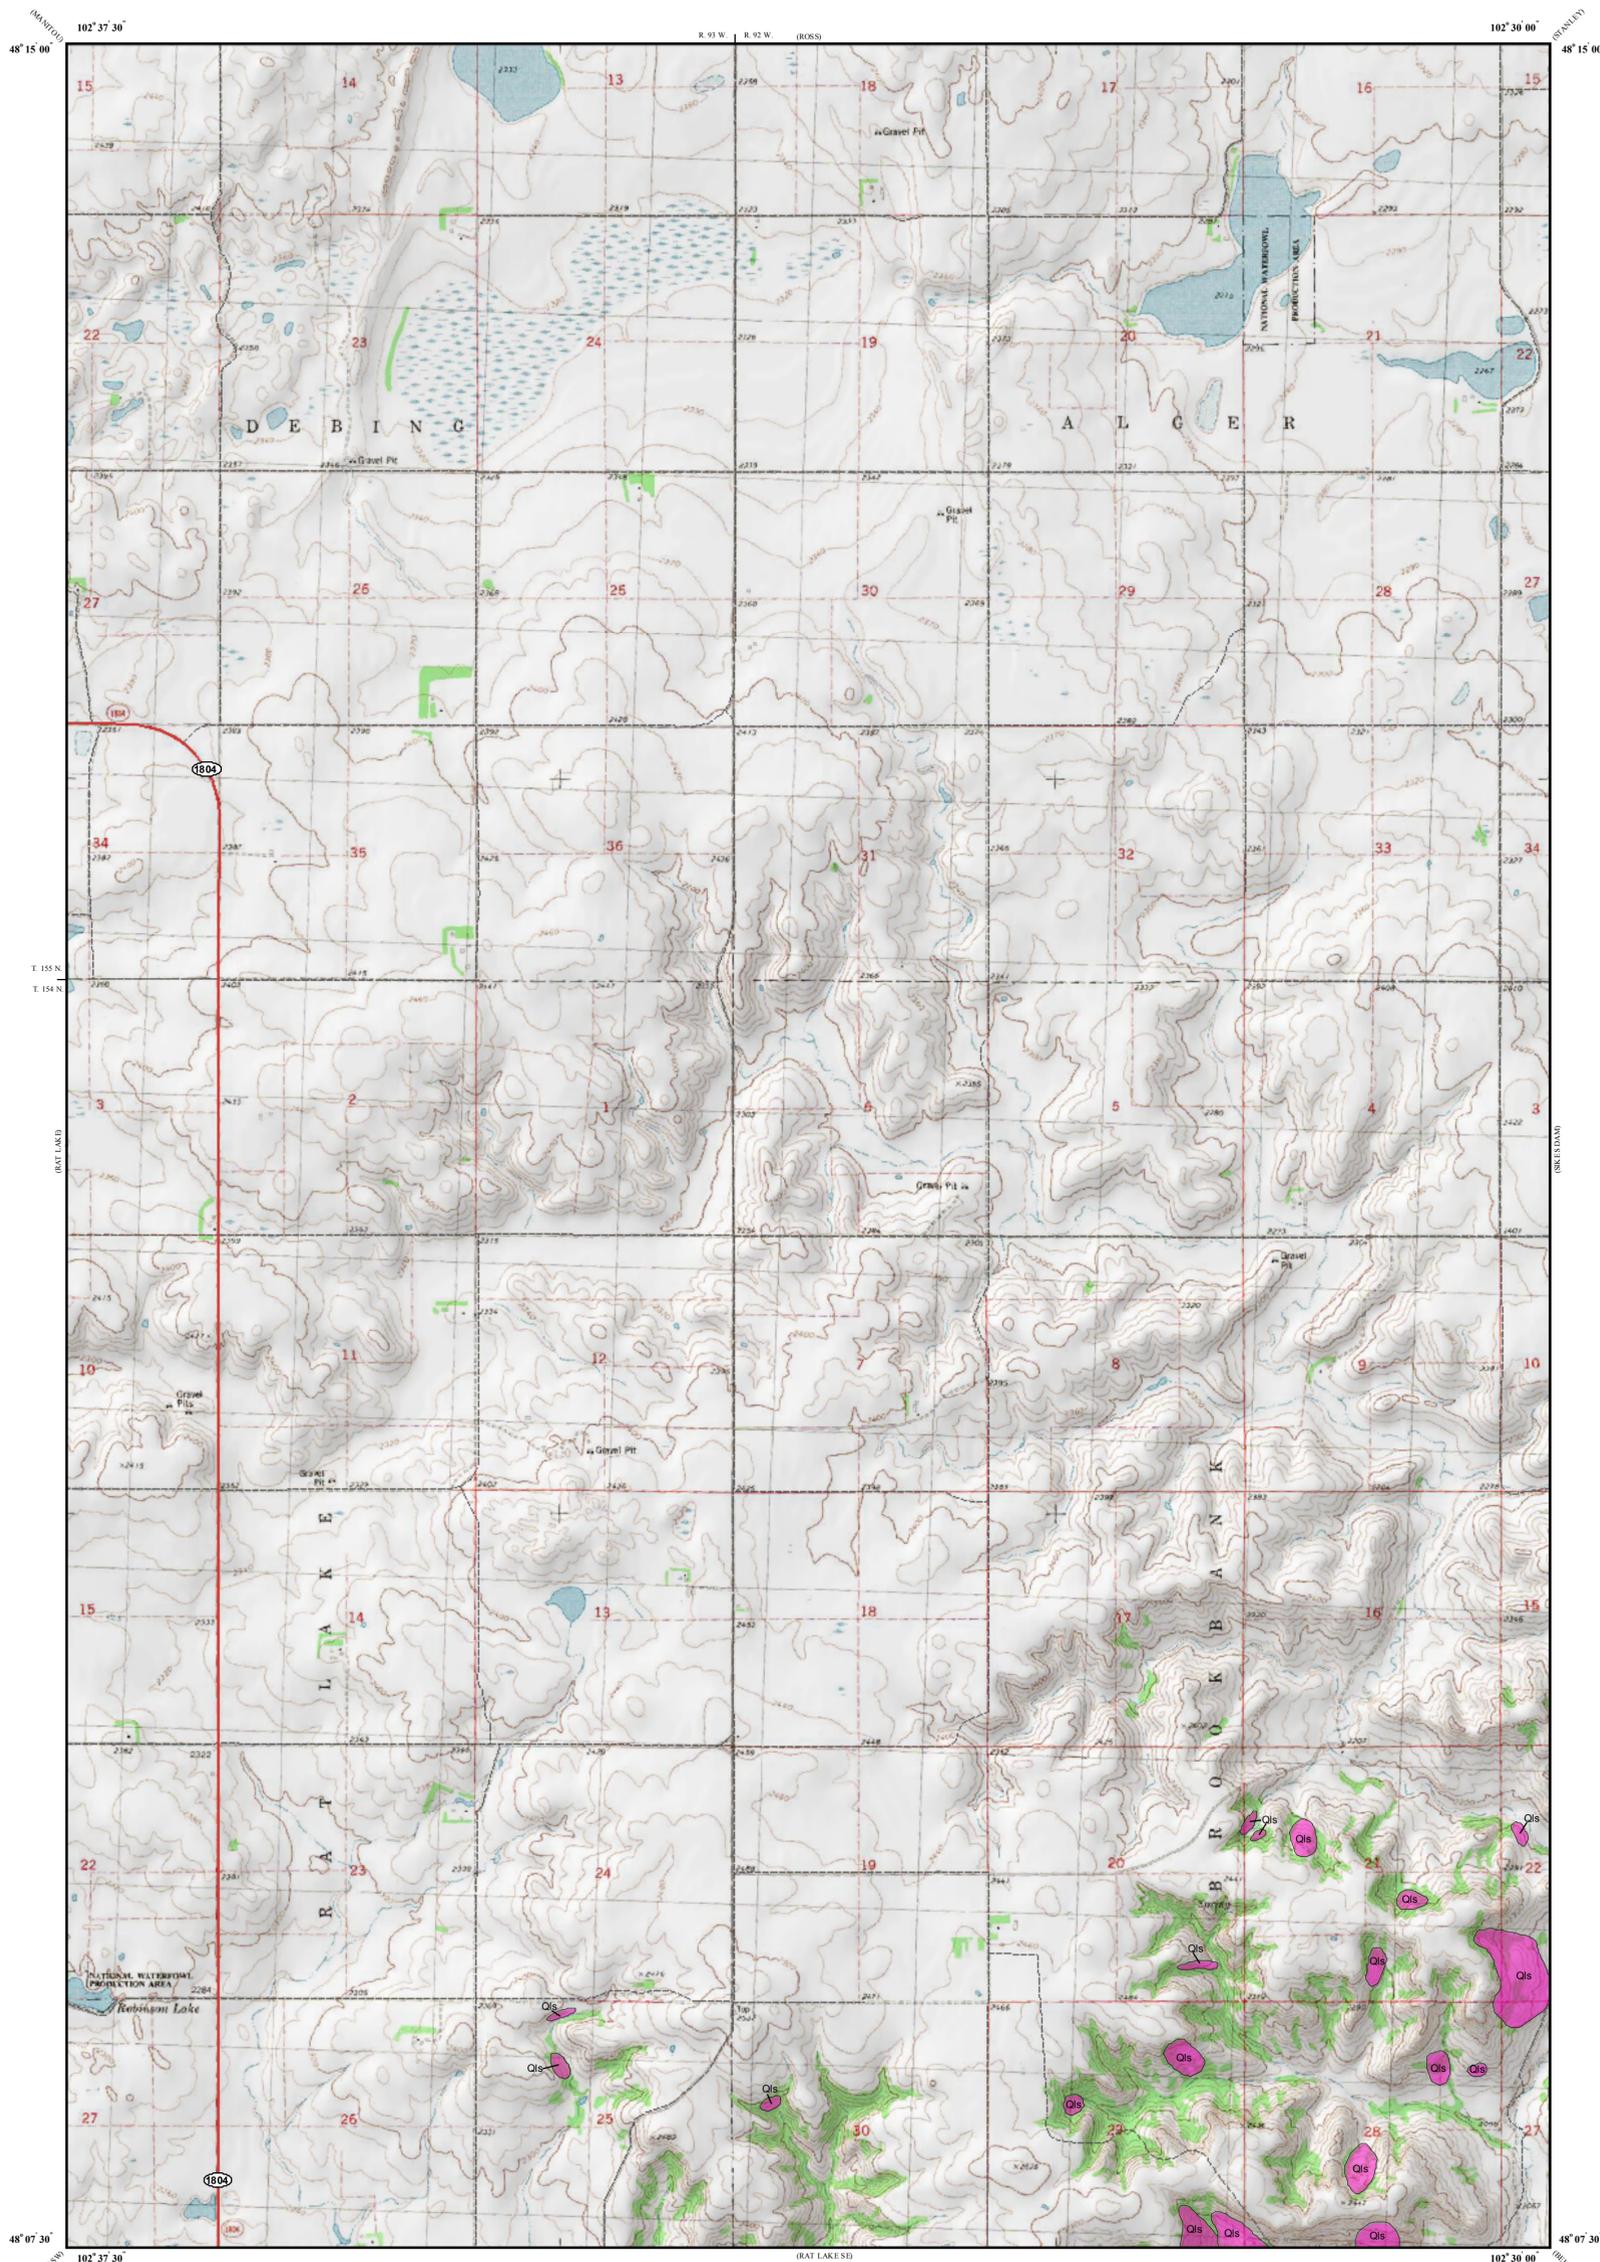
Landslides identified on this quadrangle were mapped from stereo pairs, black and white 1:20,000 scale aerial photographs flown between 6-6-58 and 9-7-58. As a result these maps can be used to identify areas that are vulnerable to slope failure, but are not an up to date assessment of all landslides for the area.
