# **Implementing Traffic Safety Evaluations to Enhance Roadway Safety**

Upper Great Plains Transportation Institute  
North Dakota State University  
Fargo, ND 58108

May 2010

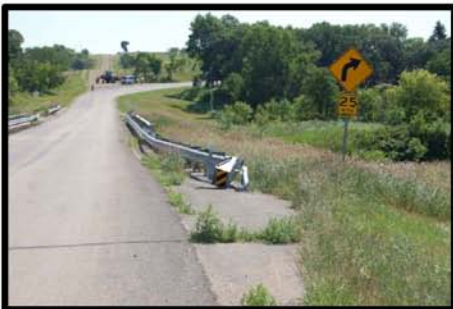
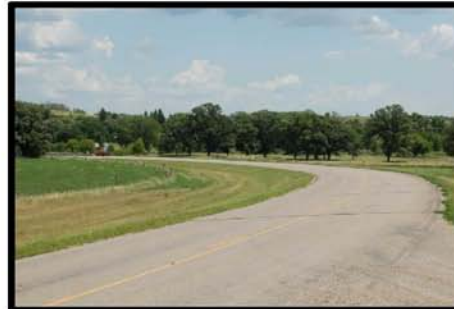
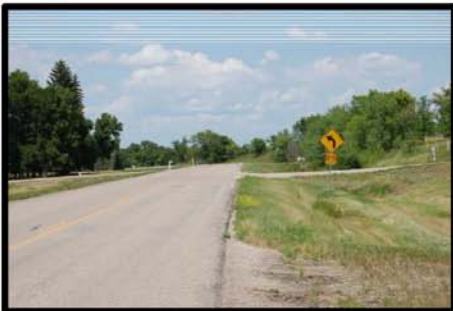
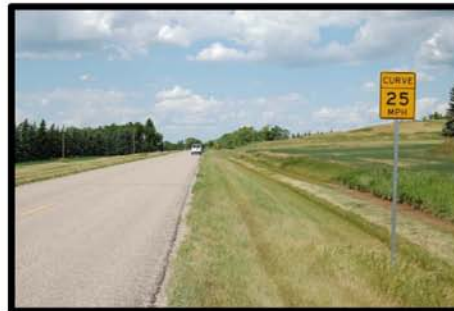
# Skorpen Curve

The bridge at the midpoint of the reverse curve is relatively narrow in comparison to the roadway, which results in the road having no shoulder on the bridge (Figure 5.9). It was observed during the site visit that the southbound guardrail attenuator was damaged, indicating that it had been struck by a vehicle. It should be noted that a road crew was repairing the guardrail at the time of the field visit.

The south end of Skorpen Curve also intersects with a gravel road (Figures 5.10-5.11). This intersection had several safety issues, which were noted by the evaluation team. Due to the alignment of the intersection, vehicles travelling southbound on Highway 21 may think that the roadway continues straight, especially in low-light or inclement weather conditions (Figure 5.9). This alignment may cause drivers to inadvertently run off the road.

Vehicles approaching Highway 21 on the gravel road from the east have several factors to consider. The approach to the intersection with Highway 21 is on a downgrade and controlled by a stop sign (Figures 5.10-5.11). This may be hazardous for drivers unfamiliar with the roadway (especially if they don't see the stop sign and think the road continues straight).

(Rank: 2.5)

**\*Approximate cost: \$37,898 (one mile length)**

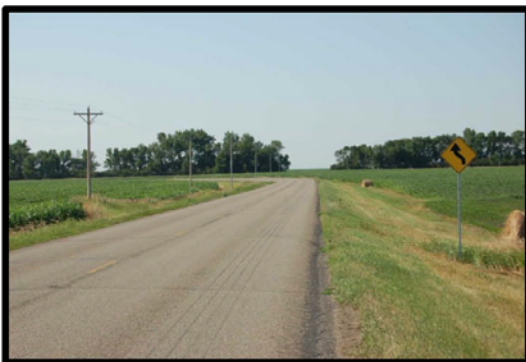
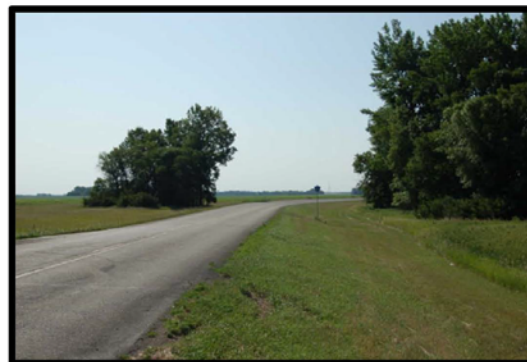
## Curve 3 mi. North of Valley City (Rank:3.5)

The first site evaluated was a large horizontal curve approximately three miles north of Valley City (Figures 5.1-5.2). It was noted that several run-off-the-road crashes have occurred at this location, with one resulting in a fatality. In addition to the roadway curvature, there are other characteristics which contributed to the safety issues at this location. An intersection with a gravel road, which isn't aligned perpendicular to the highway, is located at the midway point between the two horizontal curves. This alignment may potentially cause some sight-distance issues and driver confusion. In addition, several trees are located in the vicinity of the southern edge of the curve (Figure 5.2).

- Install edgeline rumble strips (MSHWA)
- Install centerline rumble strips (MSHWA)
- Improve curve radius/superelevation
- Widen shoulders on curves
- Improve pavement friction
- Widen lanes and shoulders (PENNDOT 2007)

**\*Approximate cost: \$37,898 (one mile length)**
